Incidents with passengers in Portugal at the platform-train interface

Faculty of Civil and Industrial Engineering Master's Degree in Transport Systems Engineering

João Marcelo Silva de Almeida Matricola: 1749613

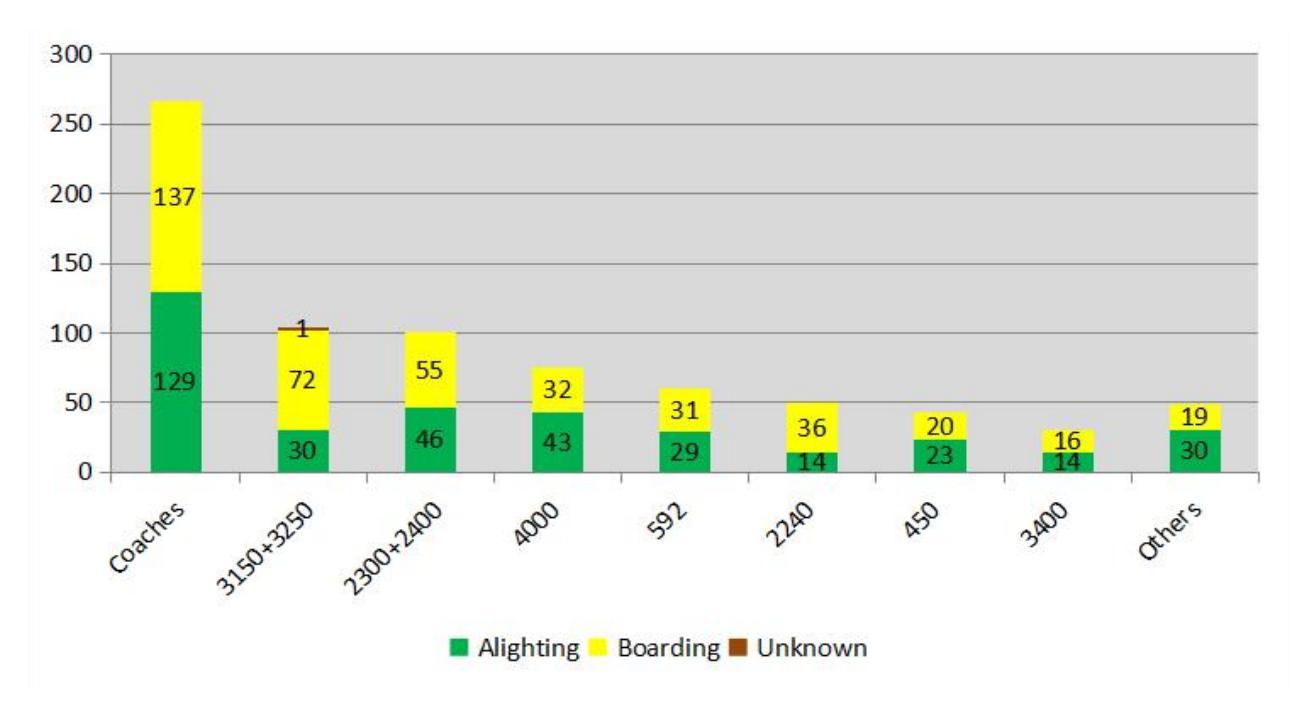
Graph 13 - Falls regarding to the rolling stock series involved

The series of rolling stocks presented in the graph represent 94% of the falls.

The coaches and 4000 are rolling stocks that operate the long-distance services; meanwhile 3150+3250, 2300+2400 and 3400 are in operation for the urban traffic in Lisbon and Porto. The others operate mainly regional trains.

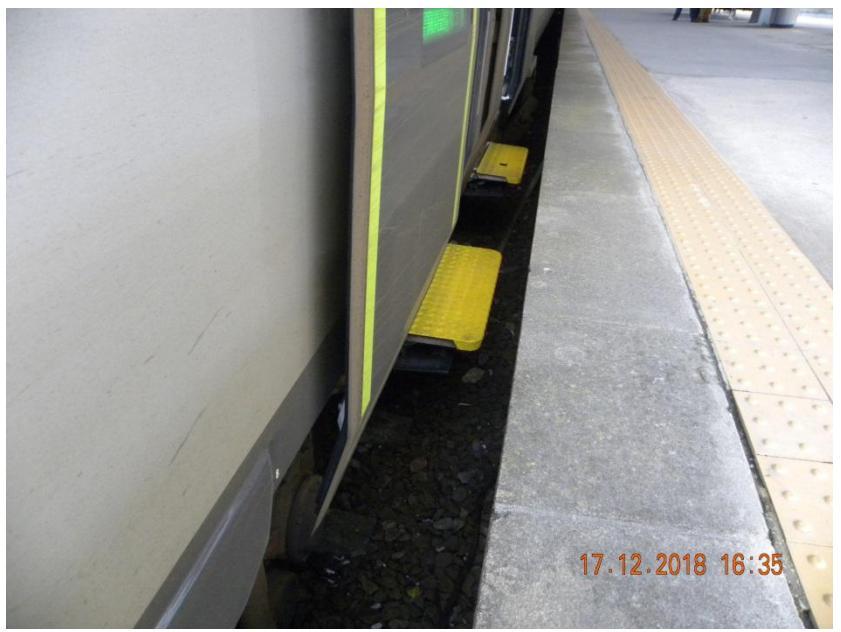
In the case of the rolling stock 4000, the last step (a folding step) is always under the platforms of the stations where these trains stop (all platforms are higher than 70 cm).

Figure 1 - 4000 in Porto - Campanhã

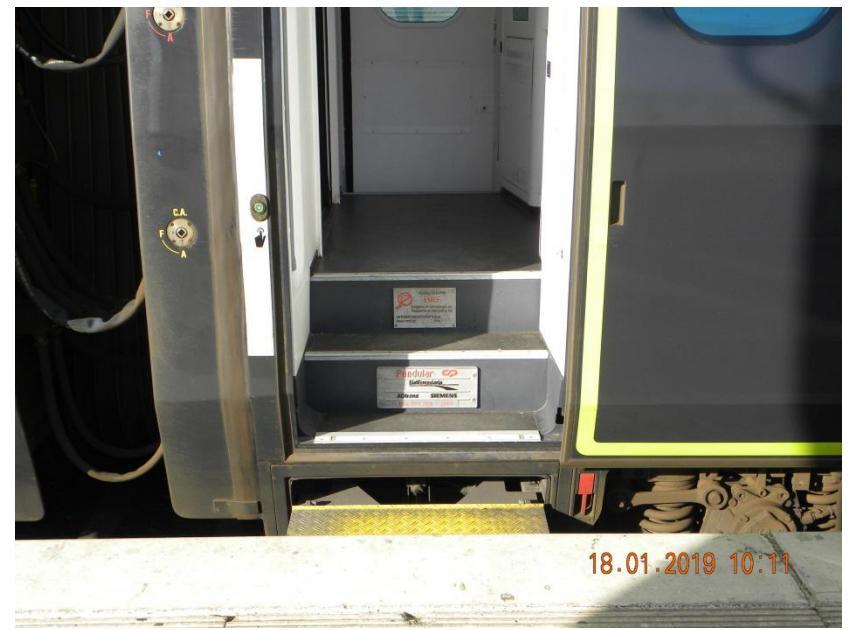
Figure 2 - 4000 in Lisboa - Oriente

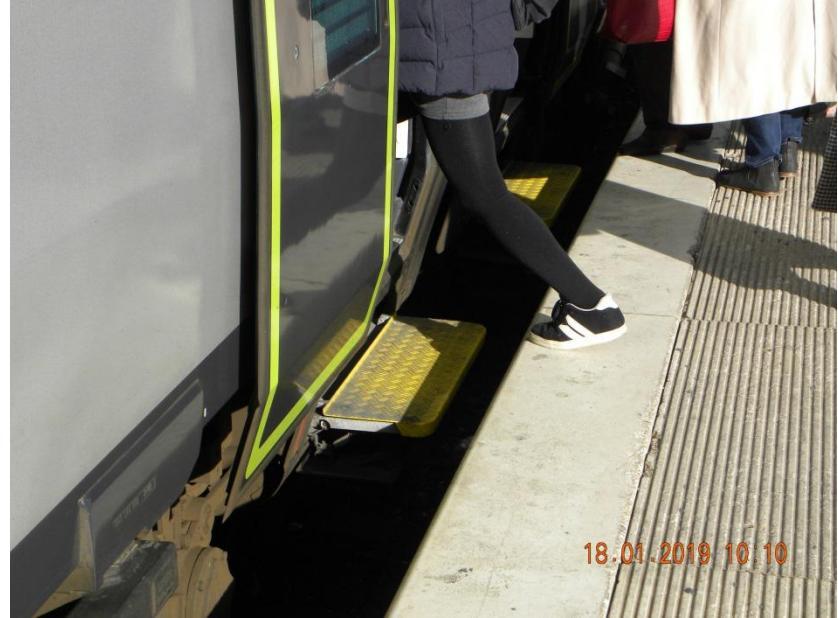
Because of this, many people bypass the last step (Figure 3).

Figure 3 - Passenger boarding in a 4000 in Lisboa - Oriente

In average, a human step is about 40 cm [11]. Due to this discontinuity on the stairs, the people decide to make a longer step. This long step plus busy hands can result in a fall.

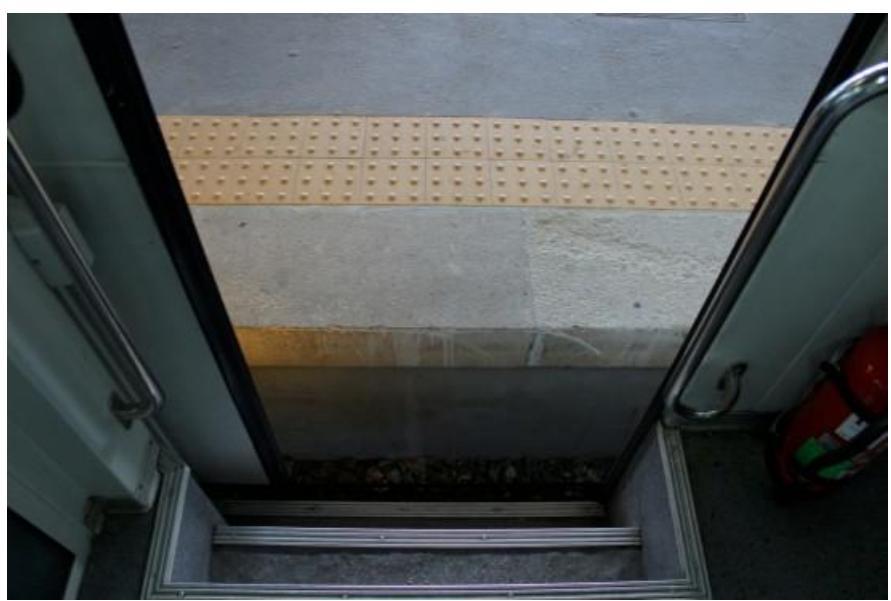
Another risk situation like that happens with the series 592 in some stations. The last step is very low in platforms higher than 50 cm. Figures 4 and 5 show how the stairs of a 592 stand in comparison to the platform of the Viana do Castelo station, which has platforms with 70 cm.

Figure 4 - 592 in Viana do Castelo station

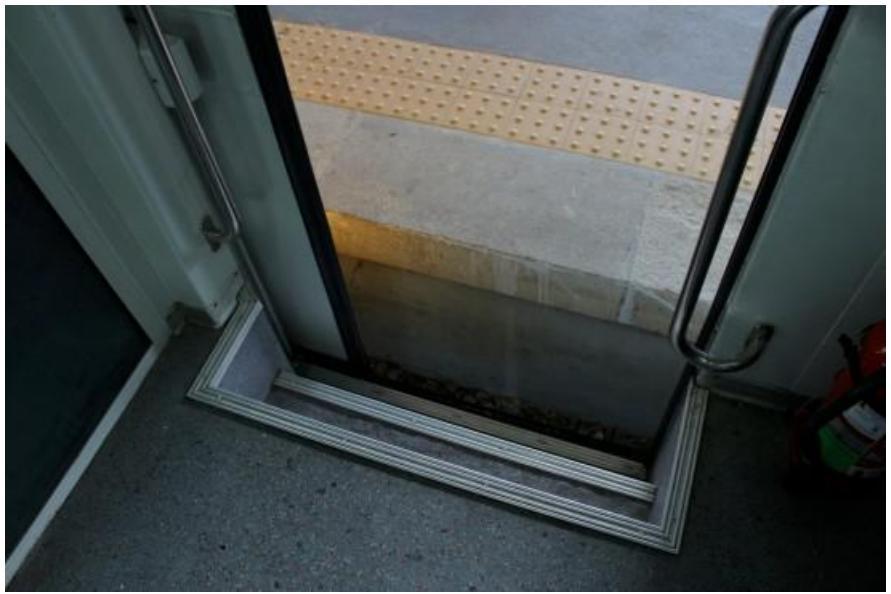
Figure 5 - 592 in Viana do Castelo station

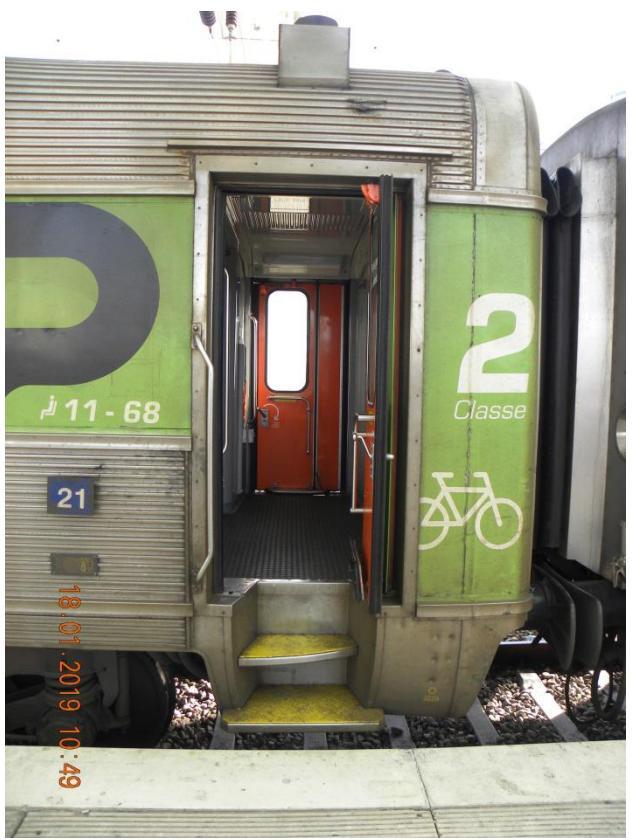
The 4000 and the 592 have large entrances and good handrails on both sides. However, the coaches, due to the type of door used (folding doors), have its entrances occupied by a part of the door (Figure 6).

Figure 6 - Entrance of a coach

In addition, this door does not have any device to lock it in the open position. It can move with very weak pull. Therefore, the handrail applied on the door does not provide an adequate support for the user.

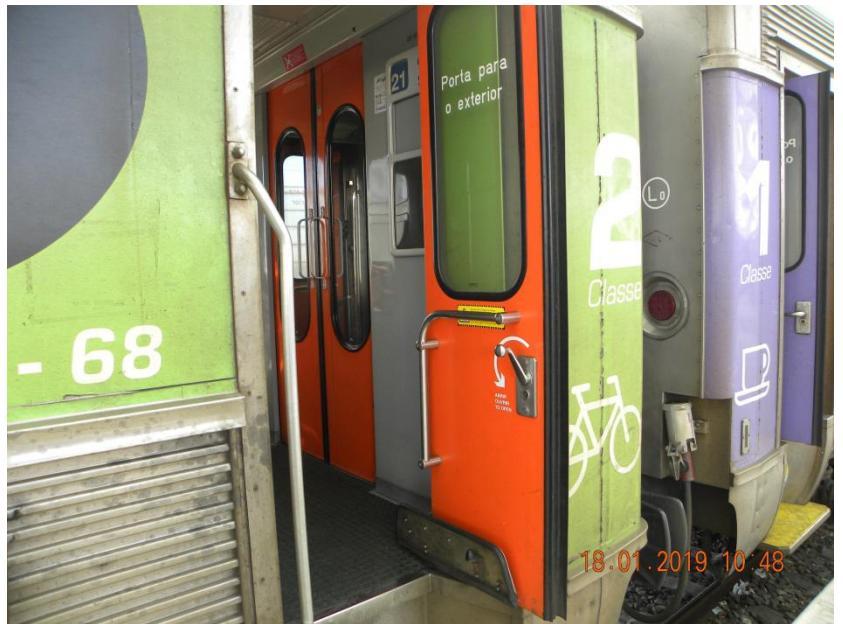
Moreover, these doors have an opening knob, which can hold a bag, and thus provoke the loss of the passenger's balance (Figure 7).

Figure 7 - Coach's door. Highlight to the opening knob and handrail

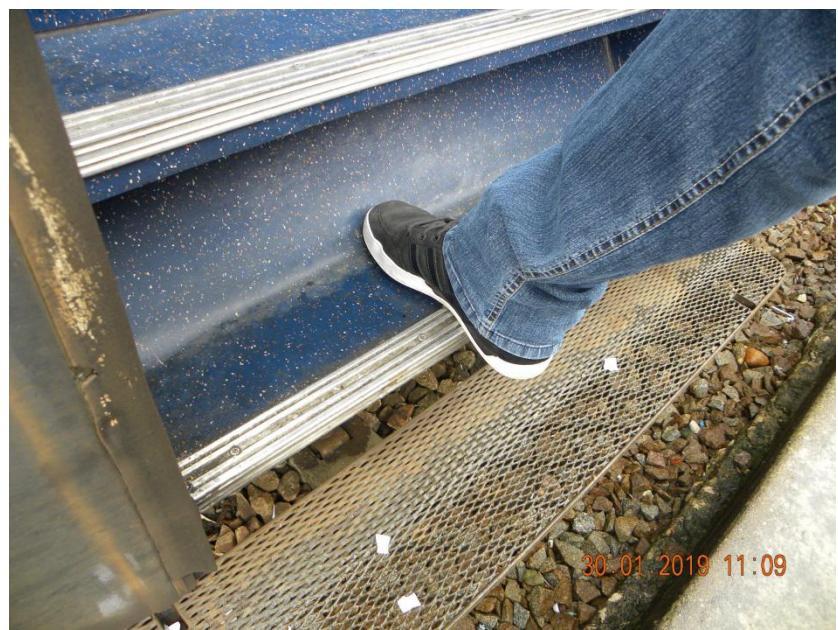
On the rolling stock 592, the stairs inside have very short tread (depth) (Figure 8).

Figure 8 - Depth of a step of the stairs of a 592 comparing to a 27cm foot

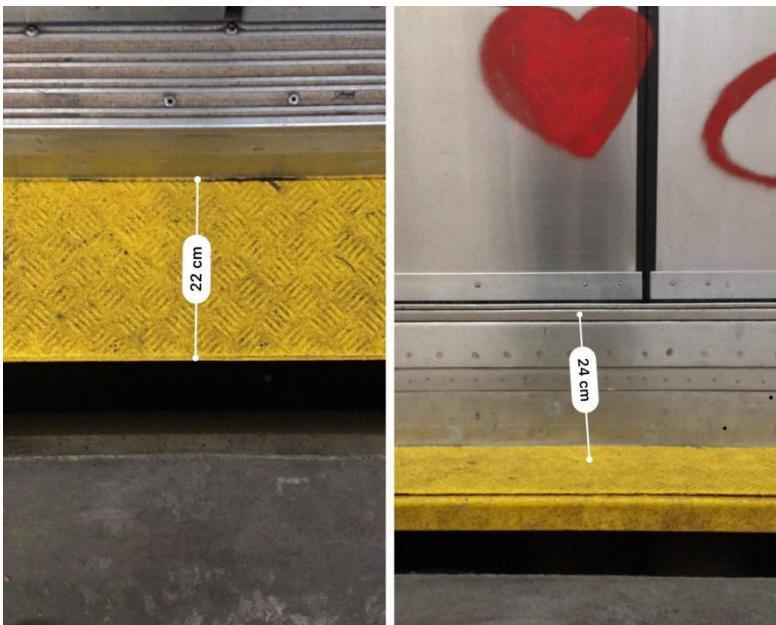
In the case of the rolling stock 2300+2400, there is no stairs inside, but, as the floor is always higher than the platform, there is an external step for the access. Specifically, this step has a higher height and lower depth than the measures used as references (Figure 9).

Figure 9 - Dimensions of an external step of a 2300+2400

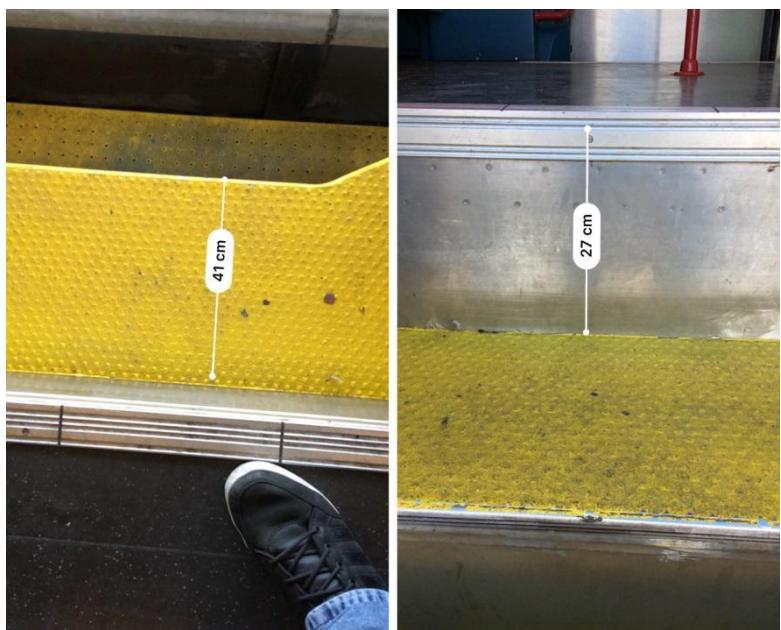
On the rolling stock 2240, which has a big concentration of falls during the boarding movement, the stairs present a good tread, but, unfortunately, the height of the step is very high (Figure 10).

Figure 10 - Dimensions of a step of a 2240

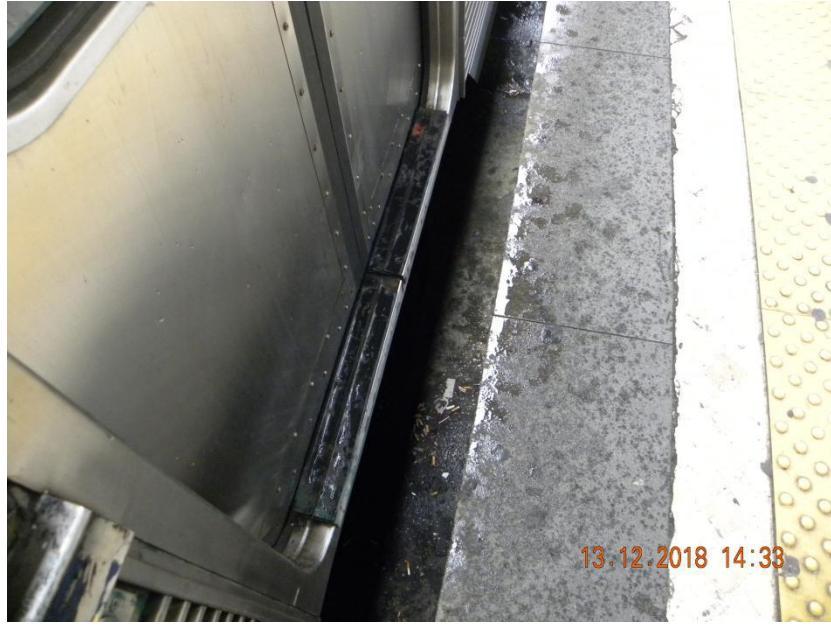
It was possible to see in a rolling stock of the series 3150+3250 stopped in Cais do Sodré station that sometimes there is no contrast between the platform's edge, the step on the rolling stock and the floor of the line (Figure 11).

Figure 11 - Entrance of a 3150+3250 in Cais do Sodré station

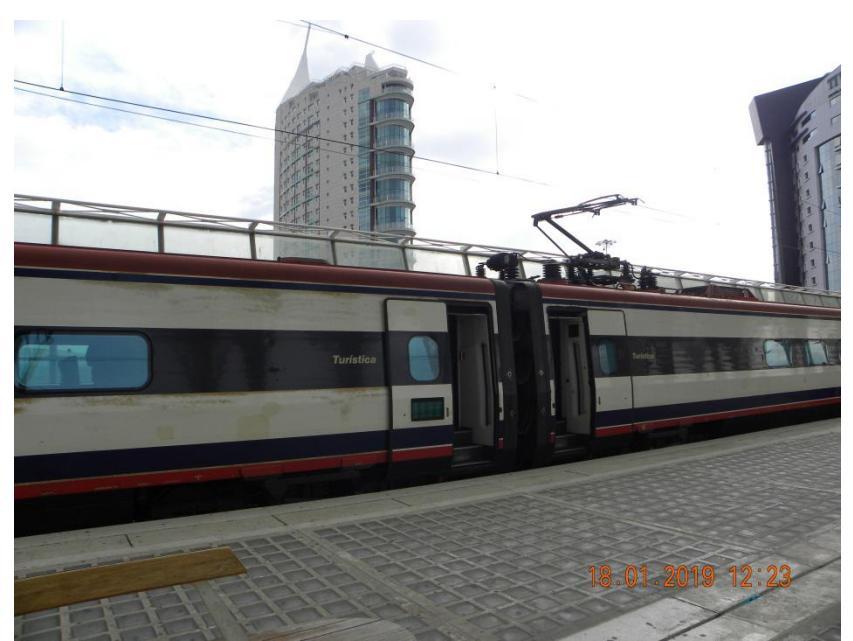
In the case of the 4000, the numbers of the cars are always the same, because it is an indivisible train. However, the identification of the cars is not so clear in some trains. It was possible to see the absence of a good identification in some situations(Figures 12 and 13).

Figure 12 - 4000 without car identification

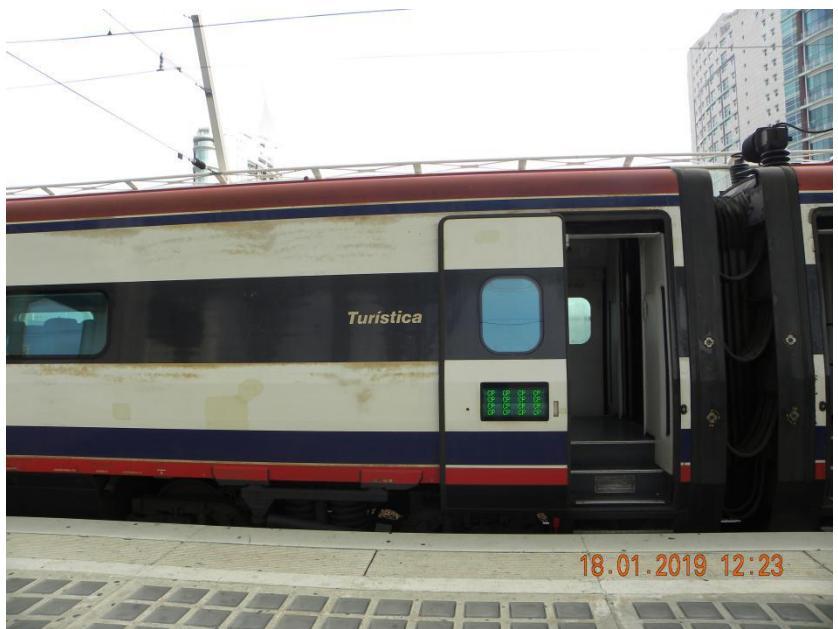
Figure 13 - Entrance of a 4000 without car identification

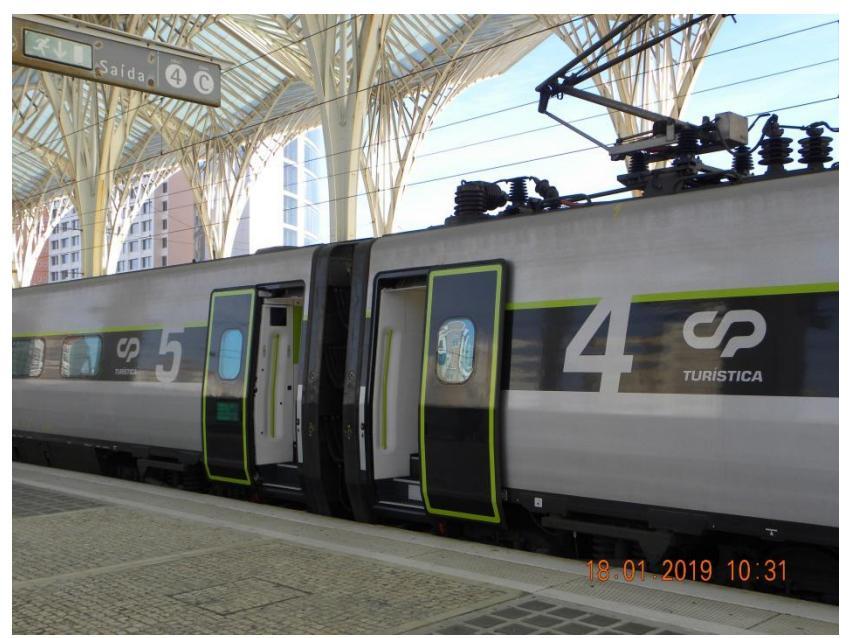
However, since the end of 2016 [14], CP has started a renovation due to the half-life intervention on the 4000, with a new painting scheme. This new painting scheme has big and clears car's numbers (Figure 14).

Figure 14 - 4000 with the new painting scheme. Highlight to the good car identification

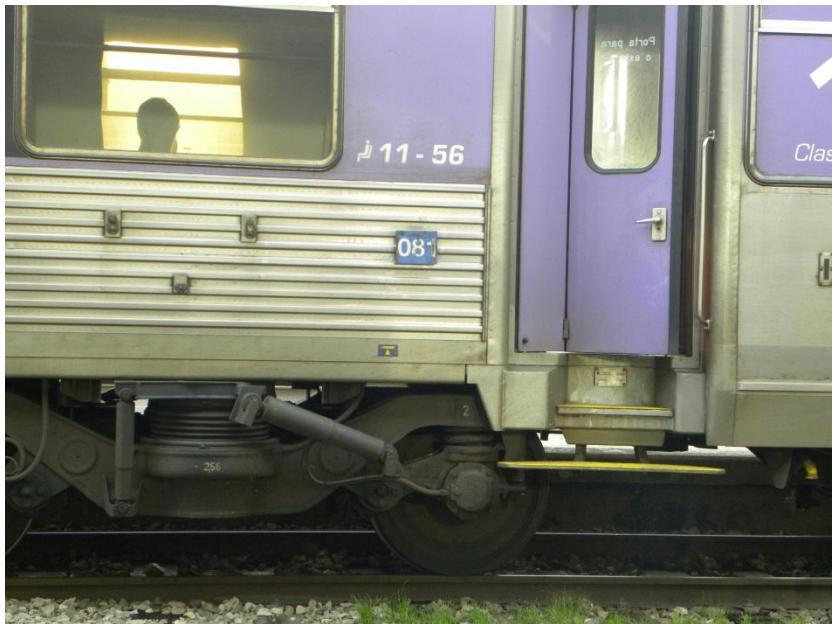
On the other hand, the coaches are single units and usable in different trains, quantities and positions. Consequently, their commercial numbers are individual per each train, with a small side identification plate, near to the entrance (Figure 15).

Figure 15 - Coach with a poor identification of the commercial number

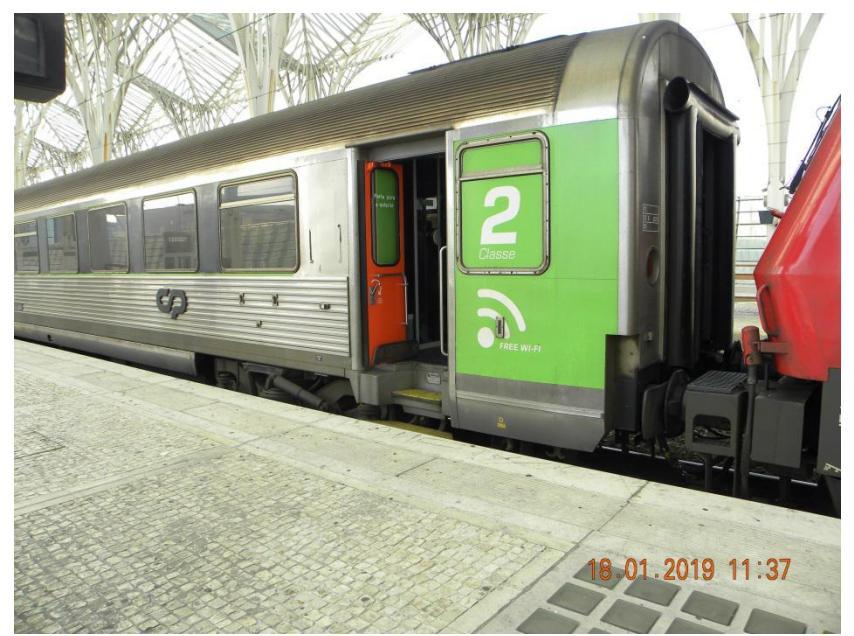
Therefore, it is very hard to see the number of the car. In some situations, the absence of the identification is complete (Figure 16).

Figure 16 - Coach without an identification of the commercial number

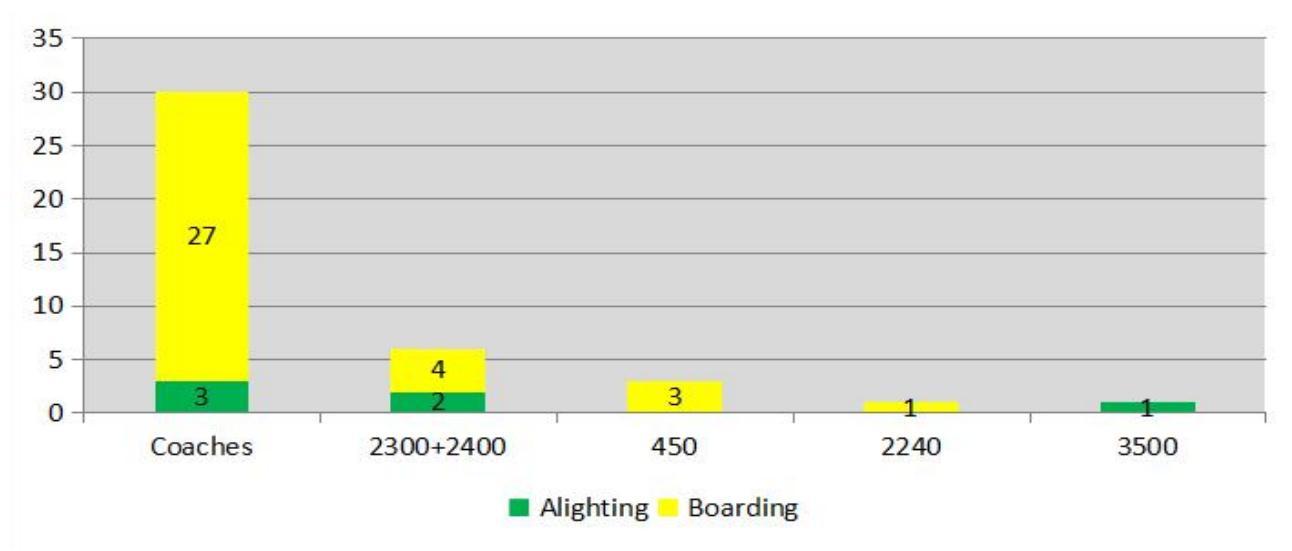
Specifically speaking about the Sete Rios station, the 3rd station in terms of falls, the biggest problem was with the boarding movement on coaches, responsible for about 66% of the incidents registered in this station. Graph 15 shows it.

Graph 15 - Falls in Sete Rios per rolling stock series

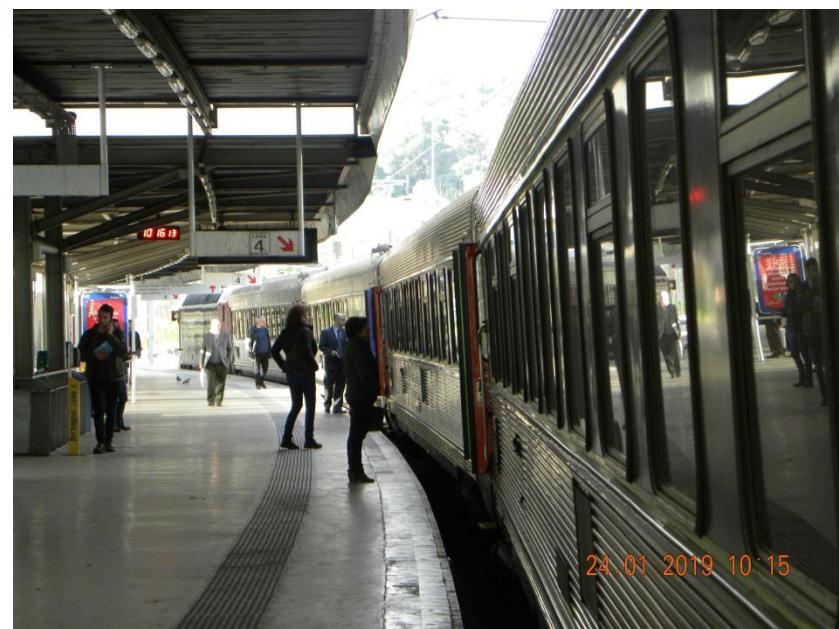
The trains southbound always stop at the platform number 4. In this case, the platform is on the left of the train and the train is making a curve to the left, as it is possible to see in Figure 21.

Figure 21 - Train with coaches during the boarding/alighting service at platform 4 of Sete Rios

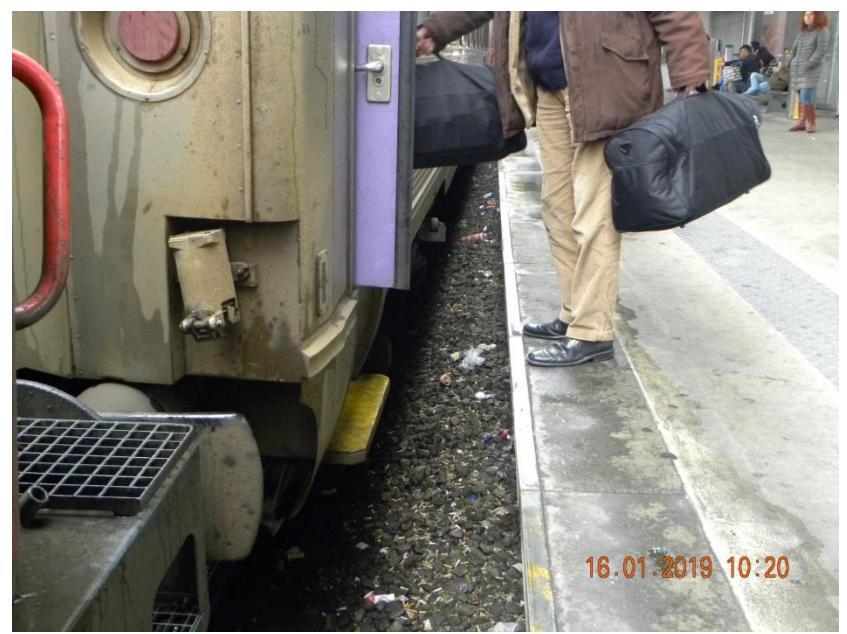
Due to the curve to the left, the platform on the left and the position of the doors of the coaches, placed on the extremities of the cars, the distance between platform and stairs increases (Figure 22).

Figure 22 - Passenger boarding in a train with coaches at platform 4 of Sete Rios

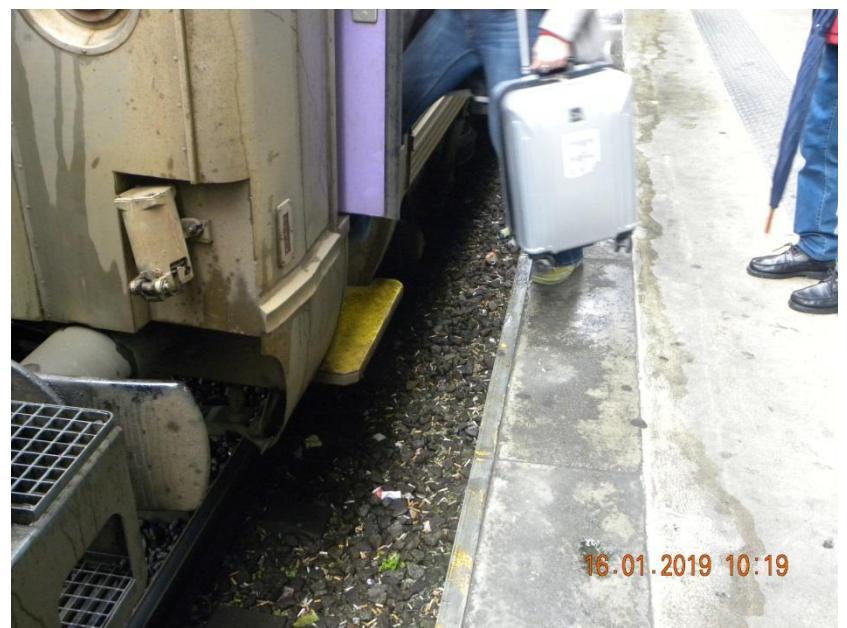
This results in a necessity of a huge step by the users in order to board on the train.

Figure 23 - Passenger boarding in a train with coaches at platform 4 of Sete Rios

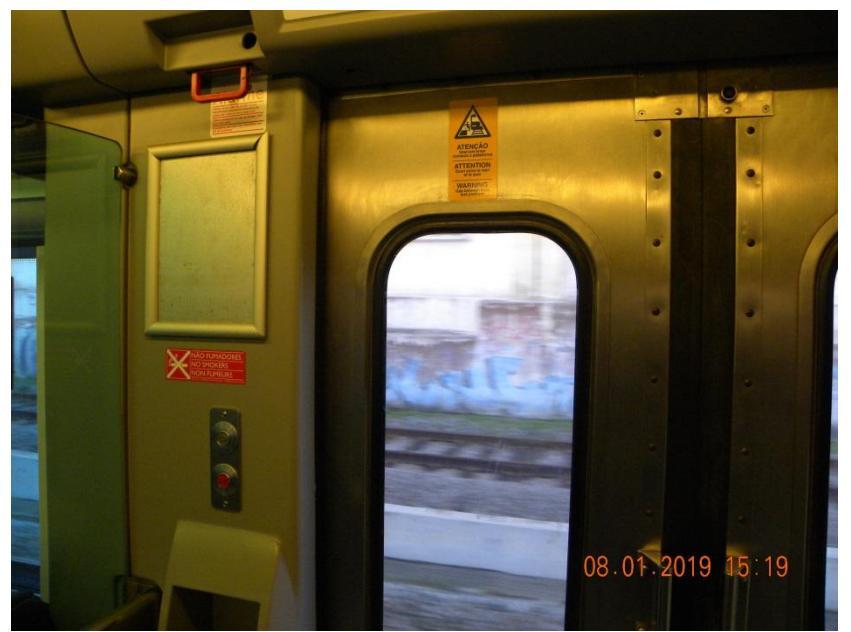
However, sometimes the position of some warnings is not adequate.

Figure 24 - Position of a warning in a rolling stock of the series 3150+3250

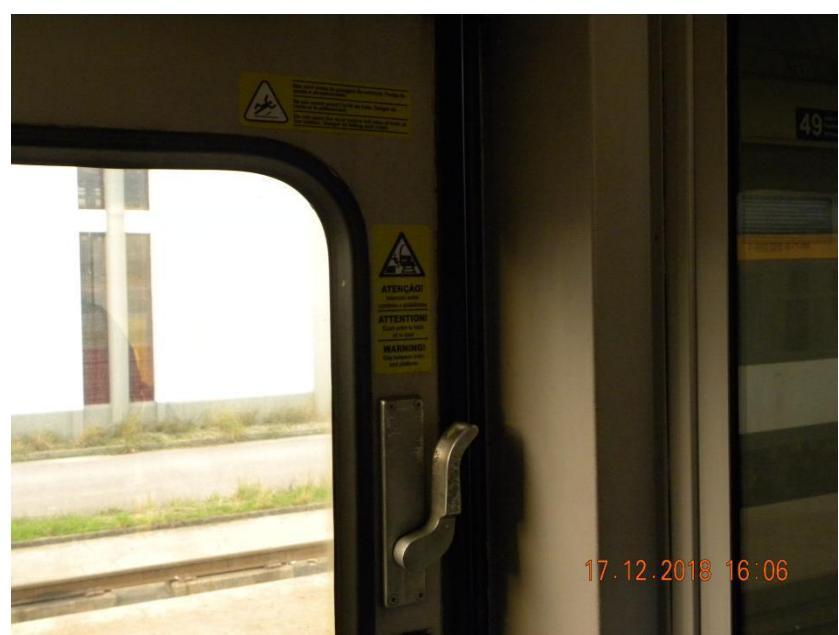
In the series 592, the warnings are very well located. They were placed near to the opening knob and almost in the same level of the view of the passengers (Figure 25).

Figure 25 - Position of a warning in a rolling stock of the series 592

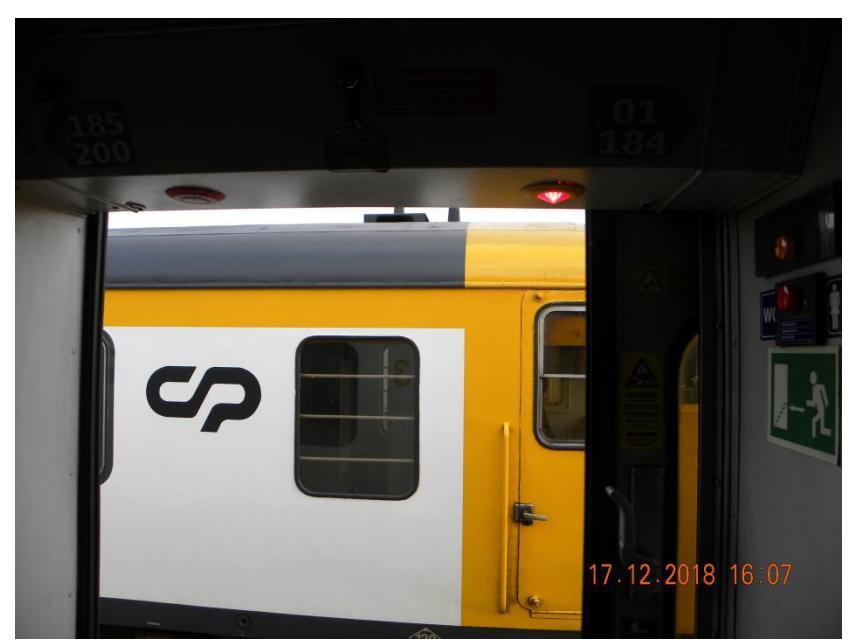
In addition, the rolling stock 592 has a light that turns on when the door-closing order is done by the driver and also a very good warning sound (Figure 26).

Figure 26 - Visual warning through the light in a 592 train

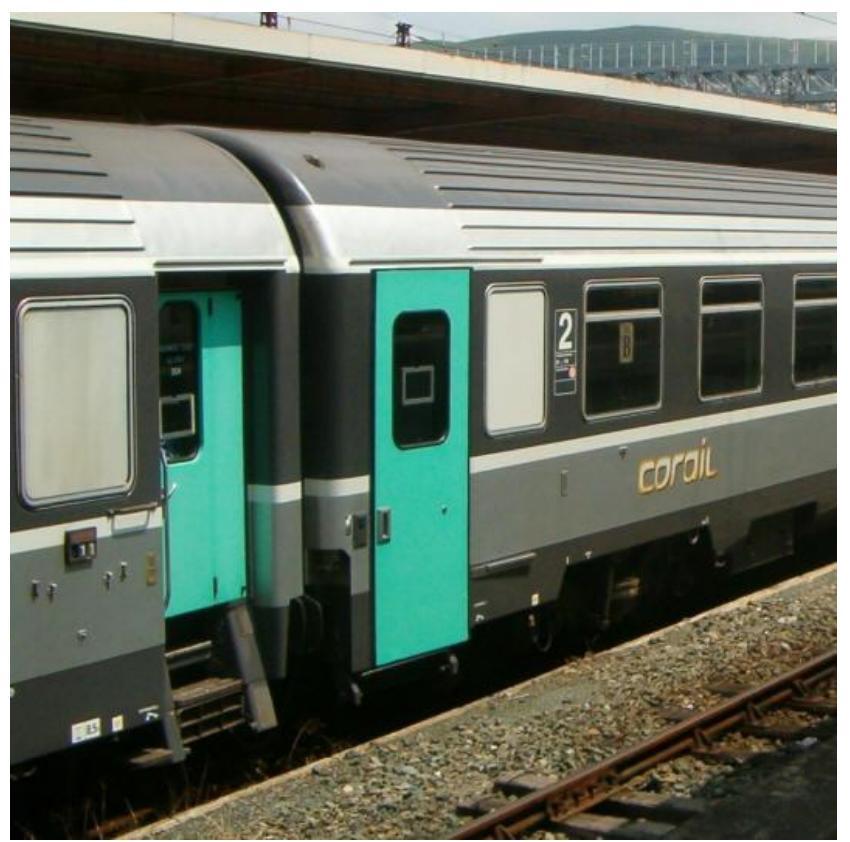
Figure 29 - SNCF coaches with folding door (left) and single piece door (right)

The SNCF (*Société Nationale des Chemins de fer Français*) has the same type of coaches as CP, but they did modifications in order to replace the folding door (Figure 28) by a single piece door (Figure 29).

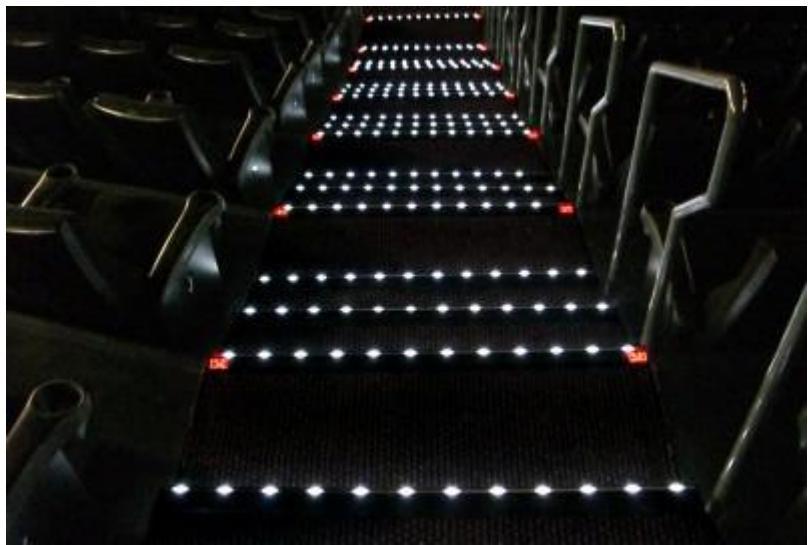
Figure 30 - LED strips in order to indicate the limit of each step

it's very important to draw attention of the people to the steps. CP has broadly applied the yellow color on the steps in a way to make the step more flashy, but there also other ways to do it, as, for instance, LED strips on the step's edge (Figure 30).

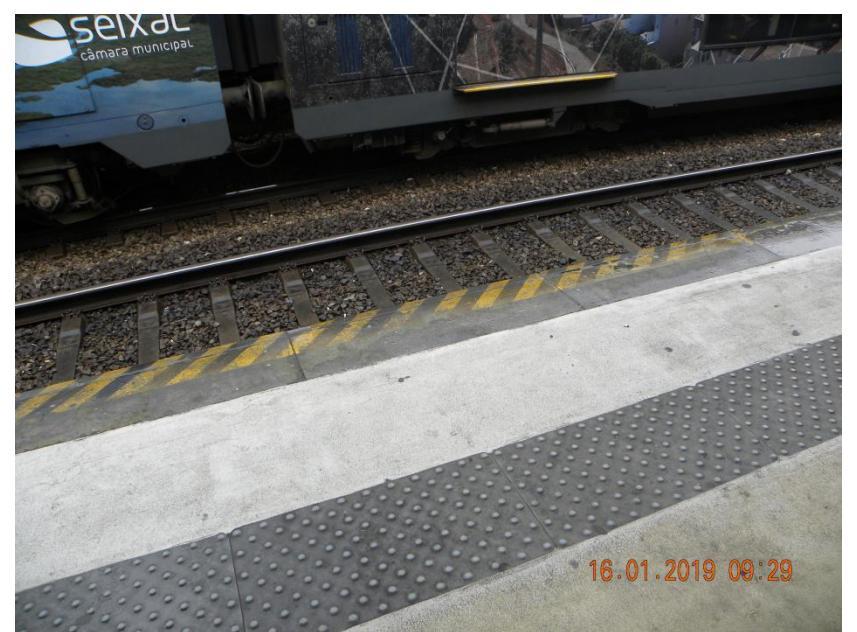
Figure 31 - Black and yellow strip on the edge of the platform in Sete Rios

Furthermore, it is crucial to draw the attention to the gap between the train and the platform. The light focus on the stairs and the yellow color on the steps could help in this point as well, but it is necessary to have something also on the platform. In Sete Rios station it was possible to verify the presence of a black and yellow diagonal stripes on the edge of the platform (Figure 31).

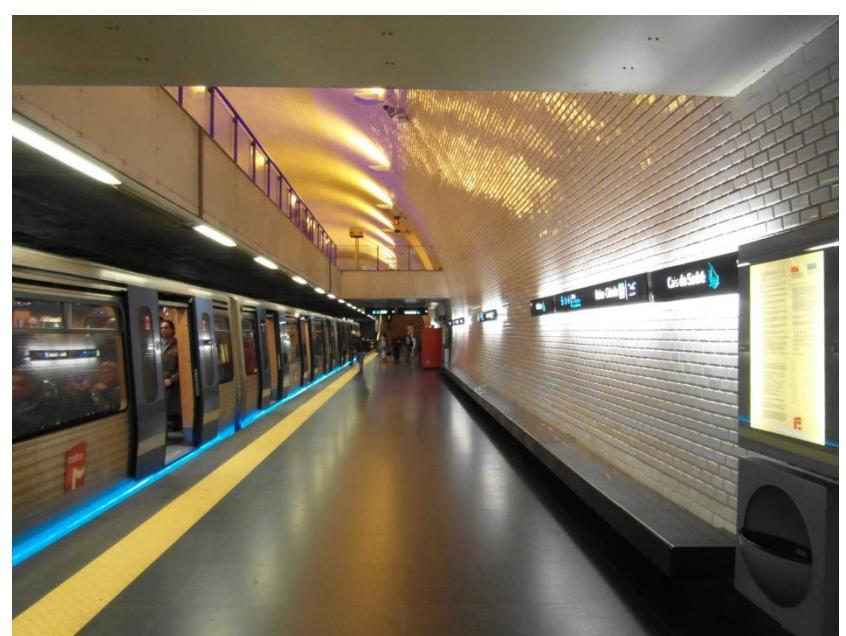
Figure 32 - Metro Lisboa Baixa-Chiado station

The Metro Lisboa applied another solution to draw attention for the platform-train gap. In Baixa-Chiado station was installed a blue light under the edge of the platform (Figure 32).

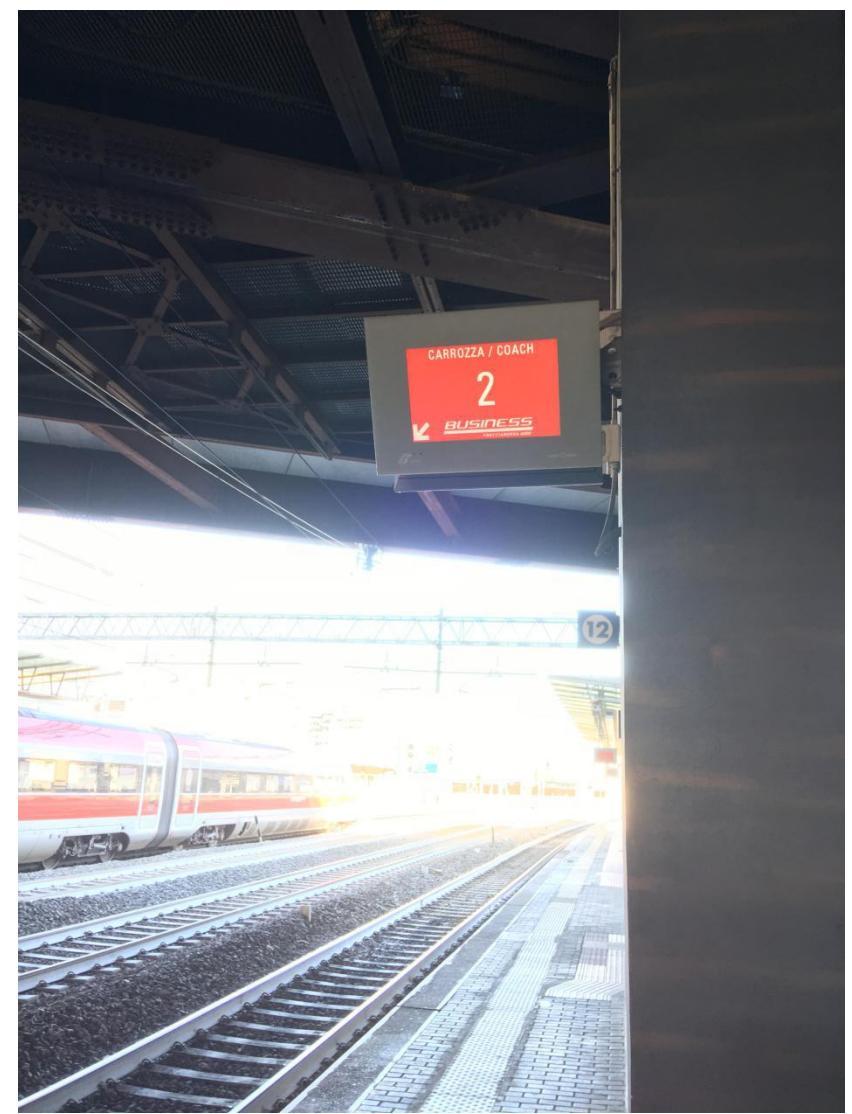
Figure 39 - Screen informing which coach will stop in this point of the platform in Tiburtina station, in Rome, Italy

One good solution was found in Tiburtina station, in Rome, and many other stations in Italy, where there are screens informing the passenger where each coach will stop (Figure 39).
